NATIONAL TRANSPORTATION SAFETY BOARD

SYSTEMS GROUP CHAIRMAN'S FACTUAL REPORT ADDENDUM 1

DCA13MA120

Location: San Francisco, CA
Date: July 6, 2013
Time: 11:28 PDT
Aircraft: Boeing 777-200ER

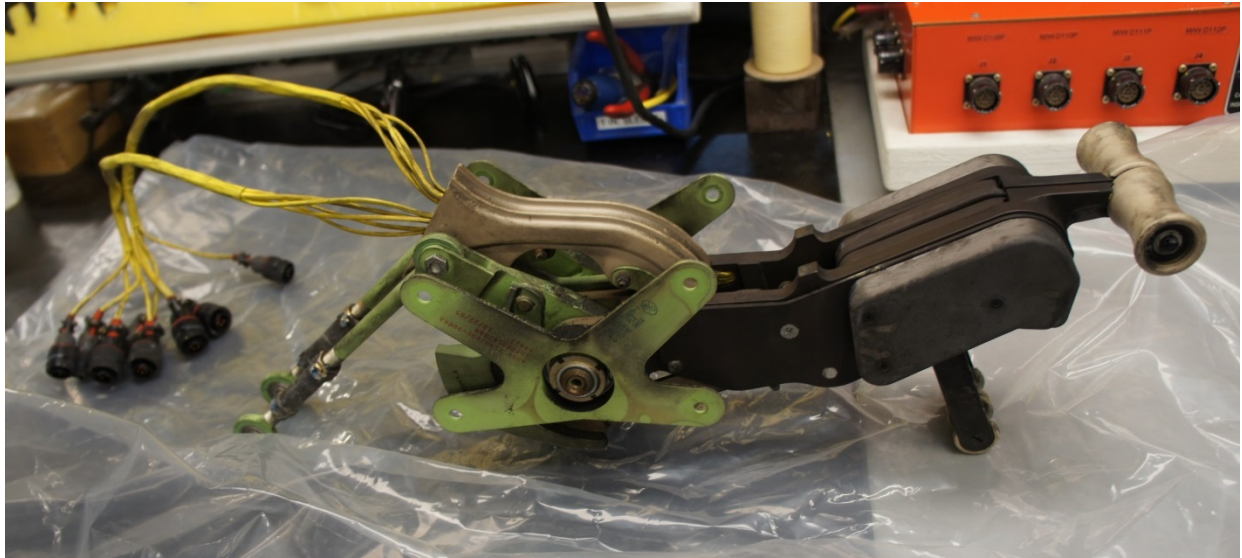
Figure 1: Thrust Lever Assembly

The components were removed from a secure room and removed from the packaging. A visual inspection was performed and the exterior of the components appeared sooty but physically were in good condition (see Figures 1, 2, and 3). All pins at the wire connectors appeared straight and clean. The locking mechanism on Connector DM73202A was damaged and required excessive force to lock. This connector connects the wiring harness for the right resolver transmitter. All components were lightly cleaned and installed into a known good control stand. The complete control stand was then subjected to the production Control Stand Assembly Functional Test per Boeing's document 254W1100, Sheet 6, Rev A, Advance Drawing Change Notice numbers 1, 2, and 3. The portions of the functional test relevant to the autothrottle function, throttle lever function, Takeoff/Go-Around switch operation, and autothrottle disconnect switch operation were performed. The results were as follows:

The control stand passed all sections of the performed tests except for 5.4.3.5 (Right Thrust Lever Angle Resolver). This test failed because the right thrust lever angle for channel A was not reading within the allowed range after the thrust lever linkages were adjusted to bring the channel B thrust lever angle within acceptable test tolerances. With the throttle levers at idle the right thrust lever angle for channel A read 31.497 degrees (test requirement was 34.0 +/- 0.25

degrees); with the throttle levers at the full forward position the right thrust lever angle for channel A read 81.699 degrees (test requirement was 84.7 +/- 1 degrees); and with the throttle levers at the full reverse position the right thrust lever angle for channel A read 2.593 degrees (test requirement was 5.0 +/- 1 degrees). The root cause of the offset between the A and B channel thrust lever angle readings from the right resolver transmitter assembly was not determined.

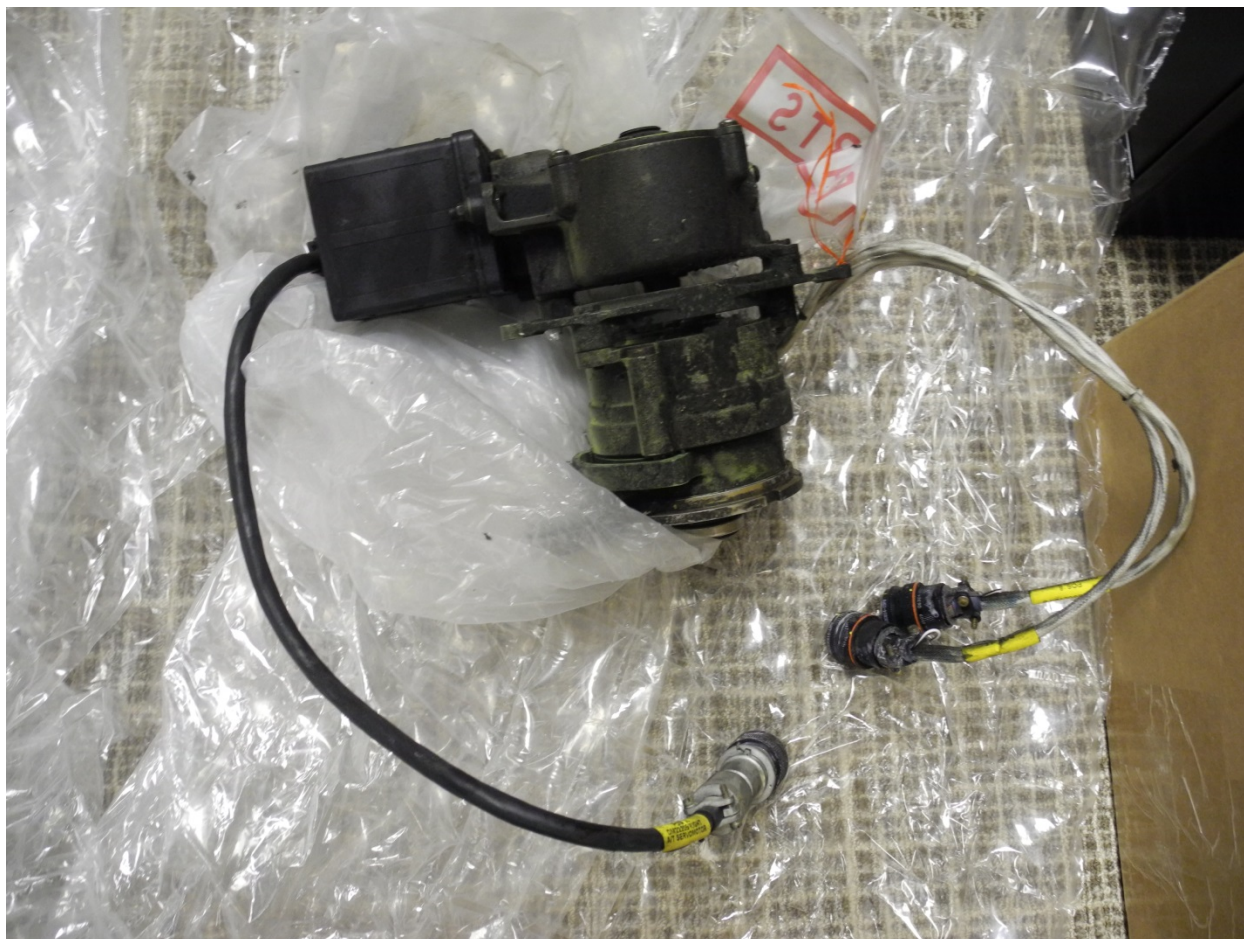
Figure 3: Right Autothrottle Assembly

During the test setup, the A and B channel readings for the right resolver transmitter assembly differed by 2.59 degrees with the throttle levers at idle, 2.62 degrees with the throttle levers at the full forward position, and 2.60 degrees with the throttle levers at the full reverse position. In each case the channel B reading was the greater of the two. This condition did not allow for rigging both channels within acceptable test tolerances. For the functional test, the thrust lever linkages were adjusted such that channel B in the right resolver transmitter assembly was within tolerance of the nominal value for the lever placed in the aft stop position. These linkages are normally adjusted during control stand build and if necessary on the airplane for proper rigging.

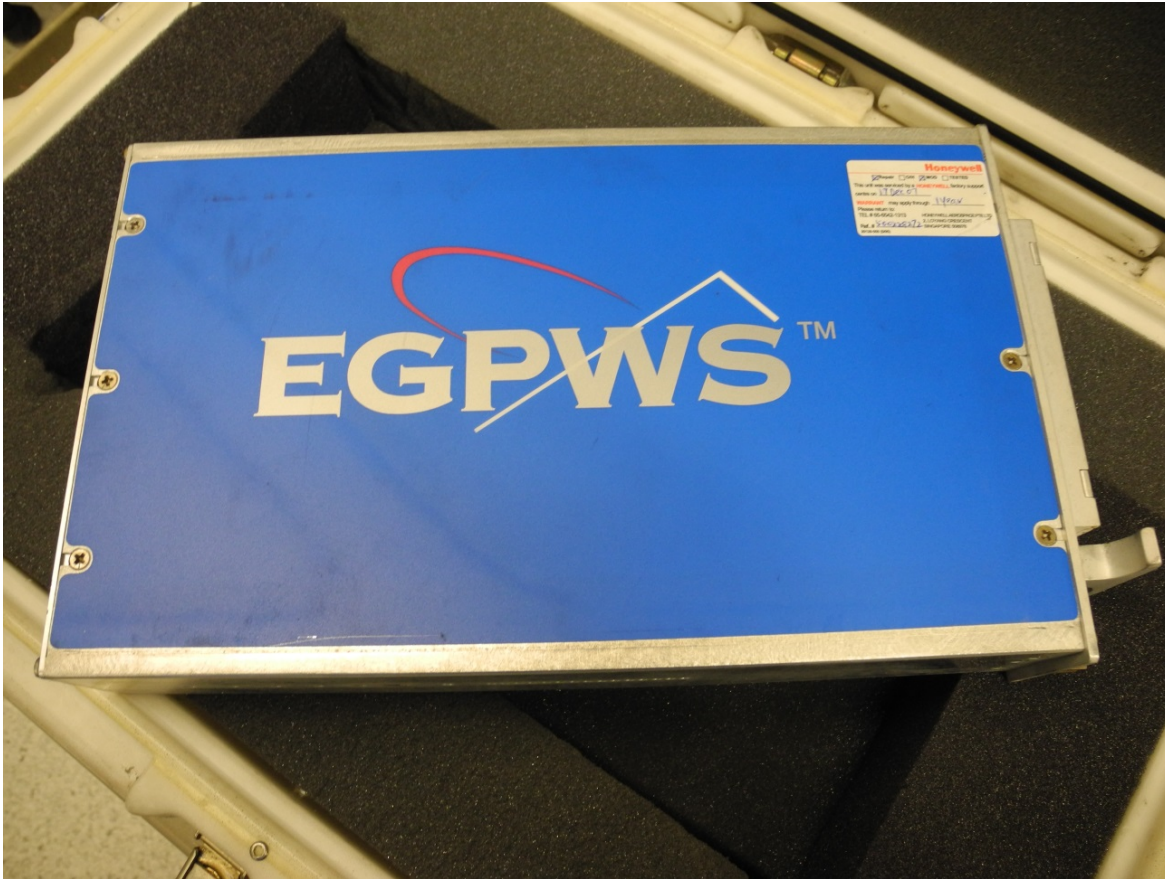
Figure 4: Enhanced Ground Proximity Warning System

The EGPWS was removed from a secure locker and removed from the packaging. A visual inspection was performed and the exterior of the unit appeared sooty around the ventilation holes but otherwise was in good condition (see Figure 4). All cover screws were flush with the cover. All connector pins appeared straight and the tamper seals were intact. The unit did not appear to have any loose internal components. “M34004” was written with permanent marker on the side of the unit.

The EGPWS cover screws were removed and the three internal circuit card assemblies were removed. The circuit card assemblies appeared in good condition with no anomalies noted. The circuit card assemblies were inserted back into the unit for the remainder of the examination.

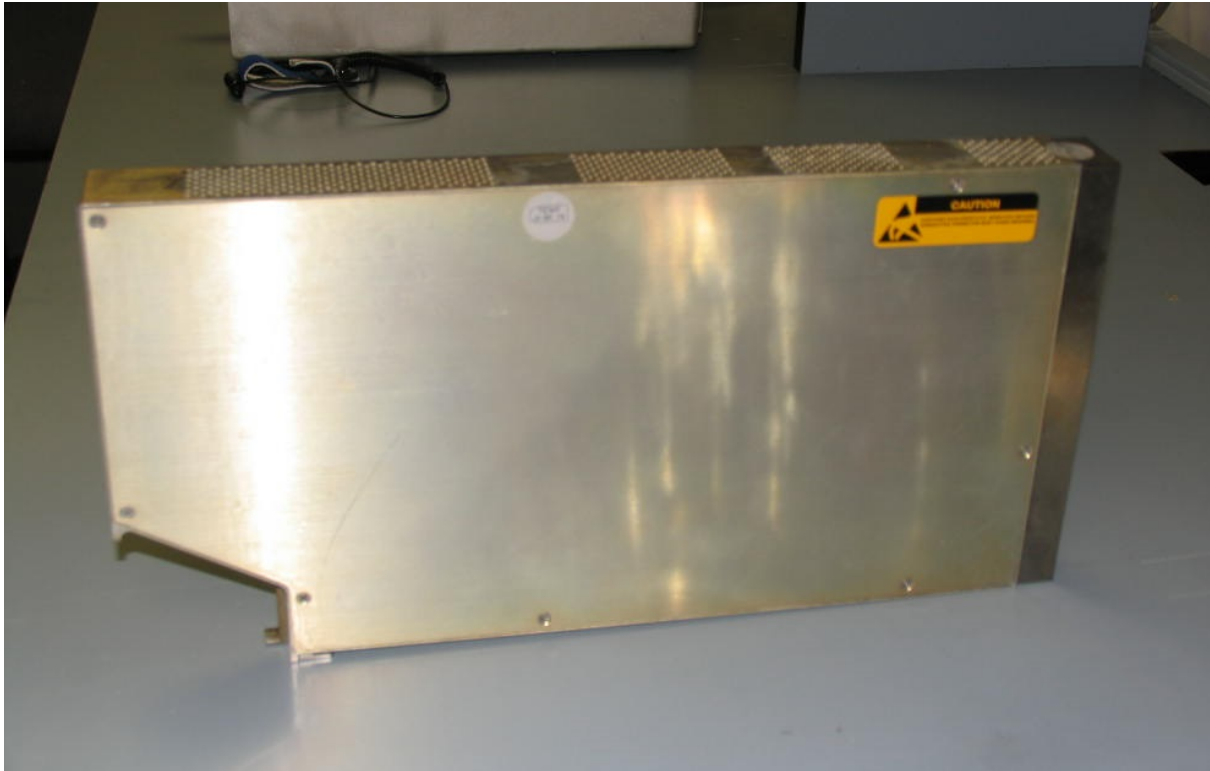
Figure 5: AIMS Module Example (S/N: 31868491)

The two AIMS modules were removed from a secure locker and removed from the packaging. A visual inspection was performed and the exterior of both units appeared dirty and/or sooty around the ventilation holes but otherwise were in good condition (see Figure 5). All connector pins appeared straight and the original manufacturing tamper seals were intact. Serial Number 31868491 was labeled as the Left AIMS module and Serial Number 31875691 was labeled as the Right AIMS module with permanent marker on the sides of each unit.
